## Spinner® Bike Pedal Fitment Repair

Models: Spinner® Ride, Shift, and Rally chain and belt drive models.  
 Mfg. Date: 09/19/2016 to 10/14/2016

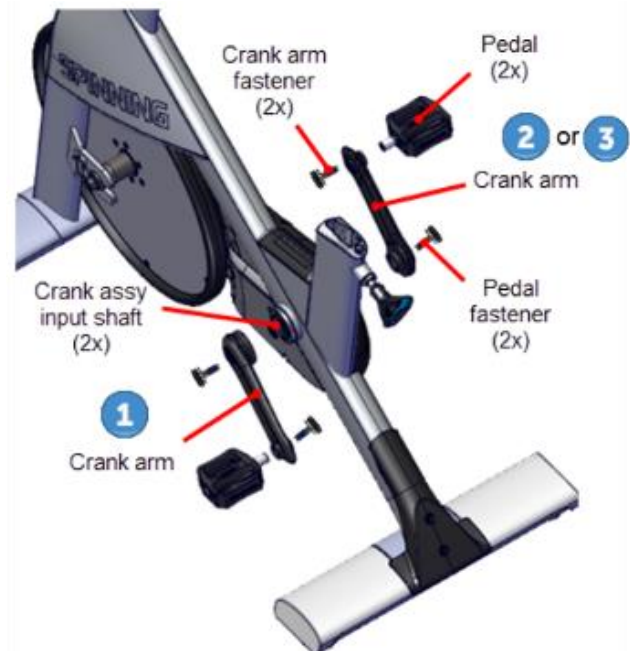
- 1 During the installation assembly, the left and/or right pedal may not fit or thread into the crank arm pedal mounting hole. Replace the defective crank with the new crank arm (left 1 or right 2), see *SBK800 Spinner® Bike Line* service manual – [Crank Arm Replacement](#) procedure.
- 2 Make sure the bike is setting firm on the floor, verify operation and return to service.
